# The Story Of A Floor

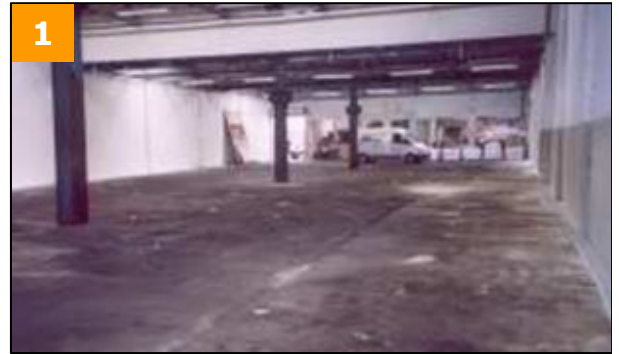
## Chapter 1.

This 1200 square metre old floor was worn, damaged, dirty and oil contaminated after many years regular use. The remedial specification involved shotblasting and hot compressed air burning to remove the contamination, followed by two coats of Tremco Penetrating Epoxy Primer, the second coat blinded with Rapide Aggregate No7.

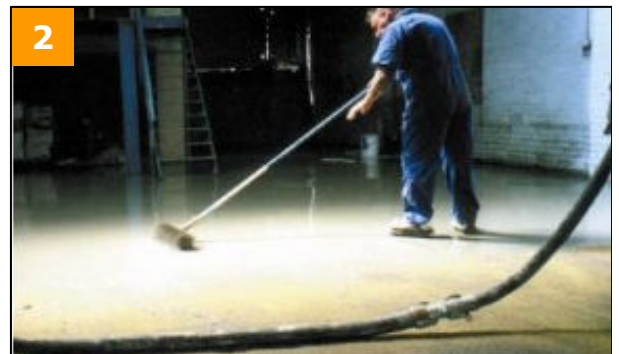
## Chapter 2.

After the primer had cured overnight, 6mm thickness of Tremco Uniflow was applied by pump. Half of the floor area was covered in only two hours.

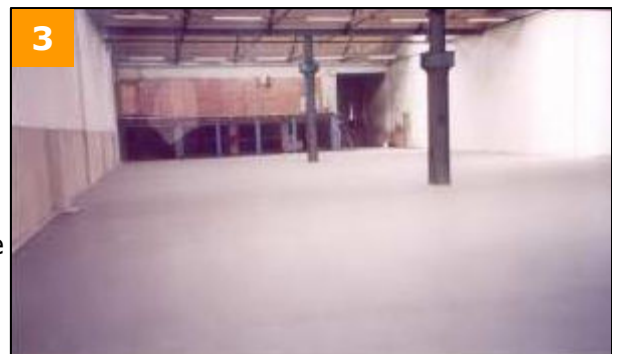
## Chapter 3.

After overnight cure the floor was hard and suitable for pedestrian and vehicle traffic

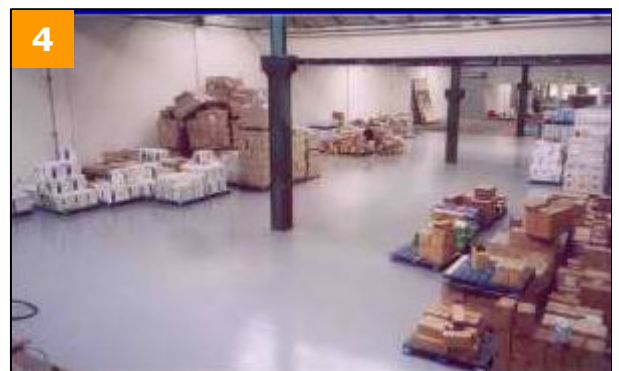
## Chapter 4.

Although not always necessary, the customer chose to have the screed painted with the highly durable Tremco Epoxicote system. The resulting floor is smooth, very hard wearing and easily cleaned.

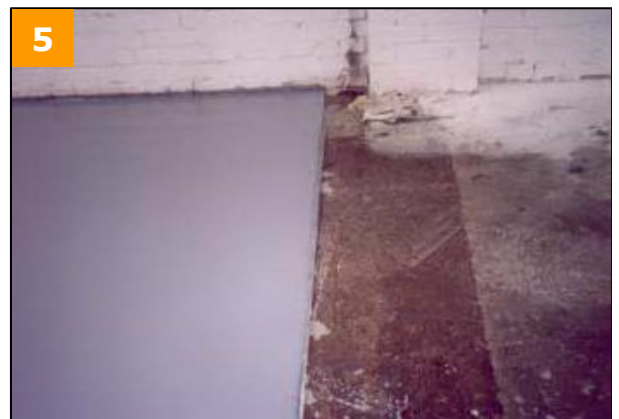
## Chapter 5.

Due to storage capacity constraints the customer required the area to be treated in two halves. The difference between before and after is remarkable as seen in the photo. The project was completed exactly to requirements.
